# SEISMIC RETROFIT OF HISTORIC TIMBER STRUCTURES: UNCERTAINTIES AND ADAPTION ON SITE

M. E. Davies, G. W. Alley & A. G. Cattanach,  
Dunning Thornton Consultants Ltd, Wellington.

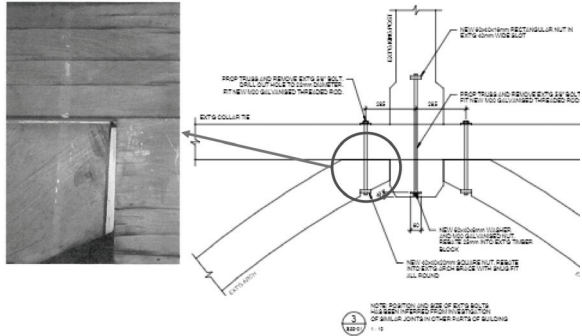
Dunning Thornton became involved with the building following the 2016 Kaikoura earthquake. Inspections and assessment after the earthquake (Clark 2016) identified that the external walls of the aisles were leaning outwards, and gaps had formed in some connections (Fig 2). The natural period of the nave and aisle structure was reported to be very long relative to other single storey structures and was within the range of periods that experienced high displacements during the Kaikoura earthquake. This theoretical flexibility matched anecdotal data of "the bells ringing themselves on windy days" and the transepts being added shortly after the original construction to mitigate swaying of the building in a northerly wind.

Figure 2: Opening of joint

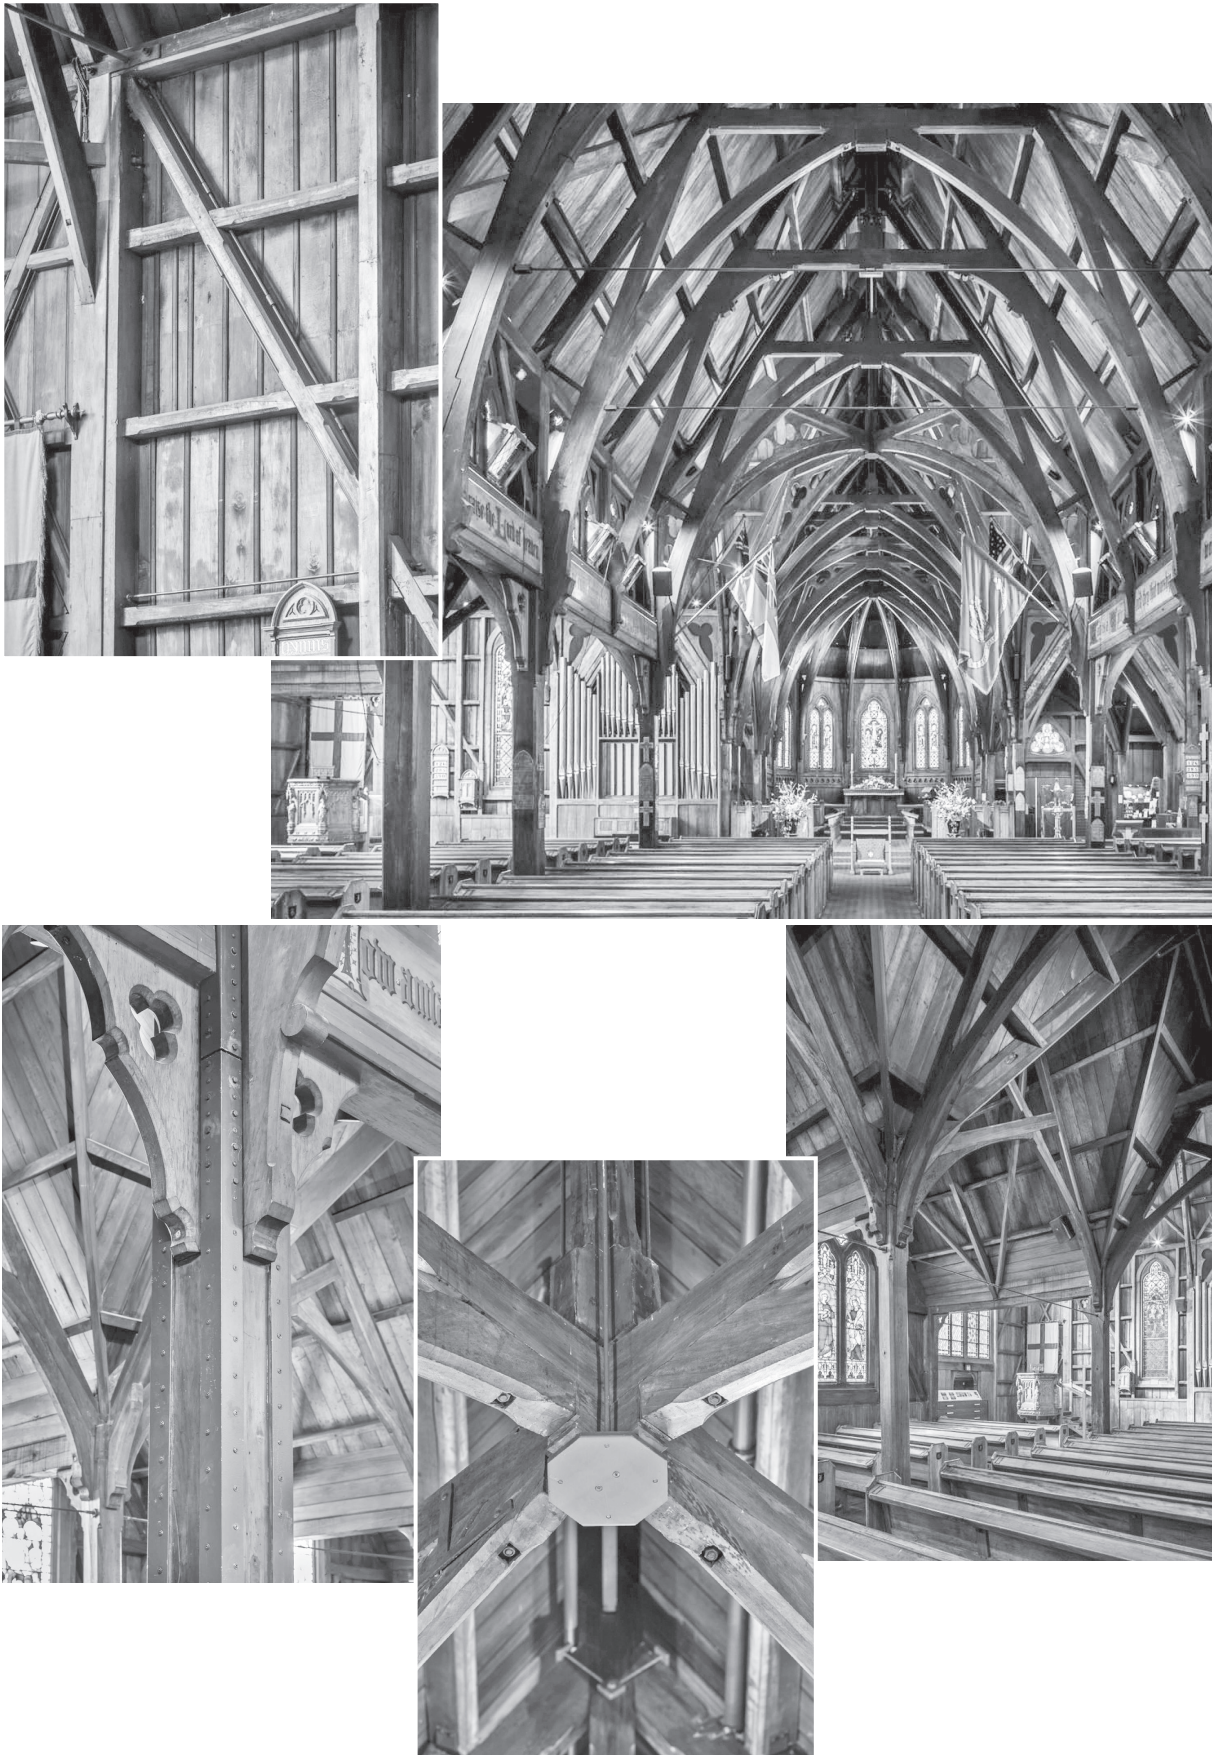
Figure 4: Clockwise from top left: new steel bars in transept wall; new transverse tie rods in aisle; new longitudinal tie rods in north aisle extension; new bearing plate in centre of crossing; repaired column in aisle.

- Installing steel bars parallel to existing timber braces to add tension capacity to the brace connections in the transept walls and bell tower.

- Increasing the available lateral strength of the transept walls and bell towers by adding mass to the foundations to increase the overturning resistance, but still maintaining a strength hierarchy where overturning/rocking occurs before failure of non-ductile timbers/connections.
- Adding tension capacity to connections in the nave, apse and aisles to improve their lateral strength, while maintaining flexibility/resilience through detailing to a hierarchy that favoured local crushing of timber and yielding of dowel-type fixings.
- Adding a small number of horizontal tie rods to mitigate plastic dilation of timber arches.
- Creation/verification of secondary gravity load paths in the crossing to make it resilient to differential displacements from surrounding structural elements.
- Adding sub-floor bracing between existing shallow piles.

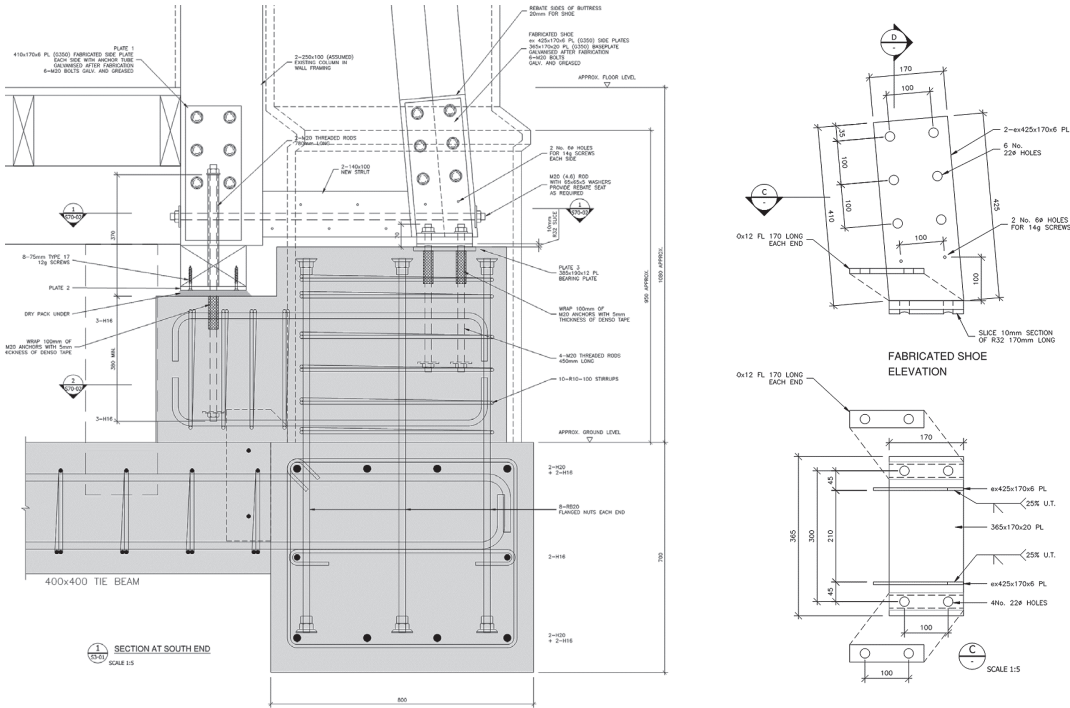
Figure 7: Ductile connection between brace and new foundation. The baseplate to the raking member can yield in two-point bending, and the hold down bolt positions are stiffened with half rounds to allow for this movement.

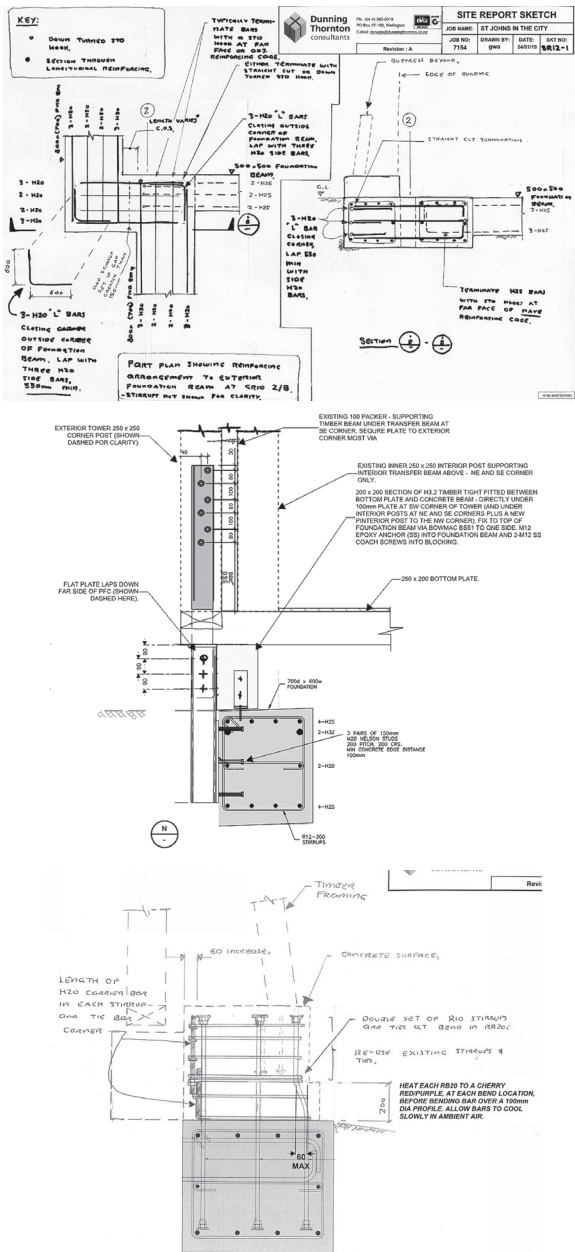
To achieve hold-down to piles spaced off the existing buttresses, new foundations beams were designed to work in torsion (Fig. 8). The high torsion capacity provided became invaluable to resolve many different eccentricities for the arising positions of supporting posts and tension hold-down bolts. Corbels off the main beams could be provided to resolve difficulties in access/fit-up of connection brackets. Ensuring all foundations have torsional capacity and torsion-resolving return elements is recommended.

Figure 8: Examples of site remedial details increasing torsion demands on foundations.

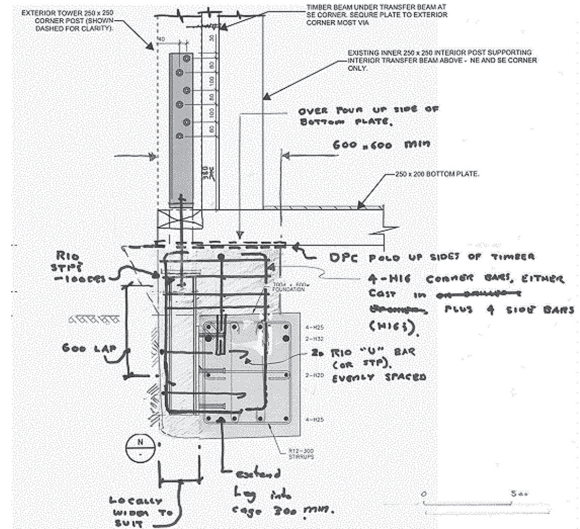
Landscaping around the North end/entrances had reduced the subfloor ventilation. Significant rot was present in both stud framing and in the larger baulks. Timbers were cut out and replaced with LVL to match strength and stiffness: deft detailing was required to maintain load paths (Fig. 9).

Figure 9: Example foundation rot remedial details

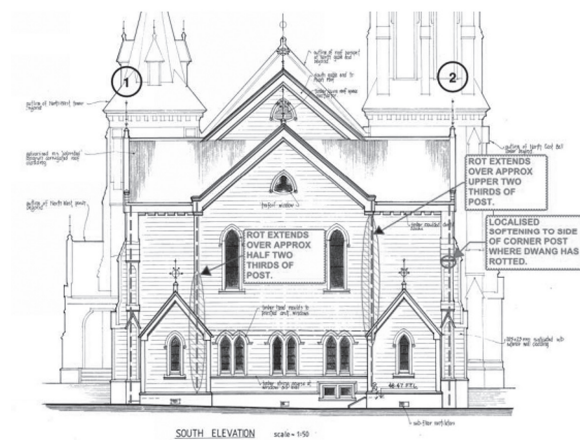
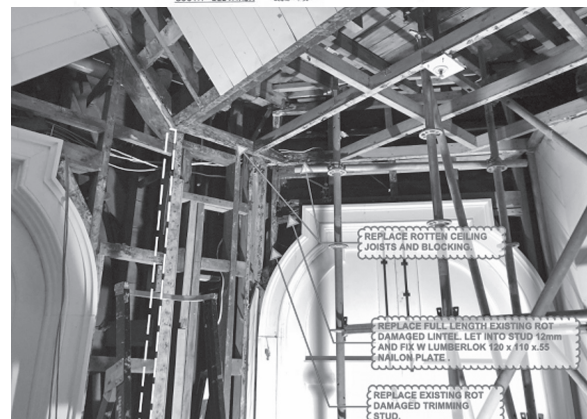
Borer was found around the gutters and internal corner details, especially towards the south wall. These were current, or more often previous, leaks where moisture content had increased sufficiently to allow borer attack (Fig. 10).

Figure 10: Example investigations and repairs

These were typically cut out and replaced where degradation was bad. Where borer had been previously treated or leaks had been fixed allowing the timbers natural dry resilience to return, core samples were taken from the wood to measure loss of density. This relatively cost-effective technique allowed the contractor to get a “feel” for assessing

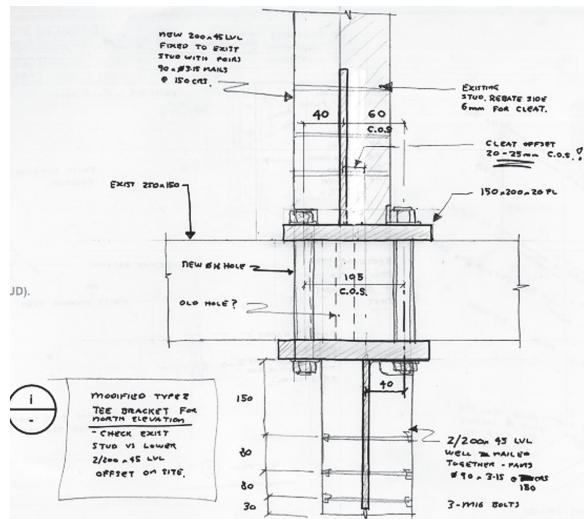
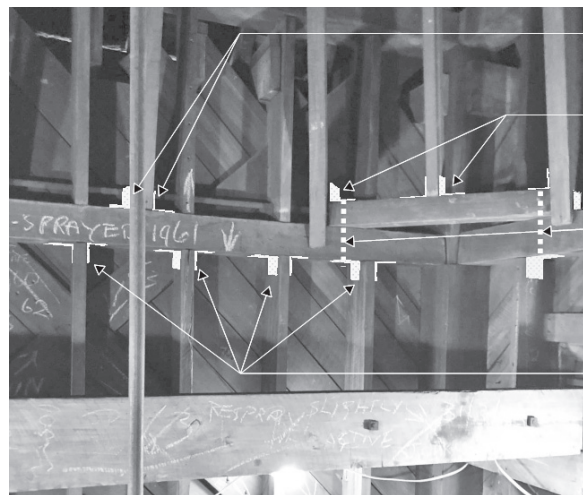
The original carpenters were careful to align gravity load-paths for downward loads. However, load paths taking hold-down tensions, especially around windows and doors, were mixed. Again, many inventive details were required for solving these (Fig. 11), as well as a critical eye on site to spot where those discontinuities could exist where still covered.

Figure 11: Example hold down alignment details.
