LESSONS FROM THE PERFORMANCE OF HOUSES IN THE CANTERBURY EARTHQUAKE SEQUENCE OF 2010-11*

G.C. Thomas¹, B Kim¹, G.J. Beattie², R.H. Shelton² and D.A. Sim³

The February 22nd and other Canterbury earthquakes resulted in substantial damage to many houses, but from a life safety perspective, performance was very good. Much damage to houses was due to lateral spreading and liquefaction, but in the hill suburbs and Lyttelton substantial shaking damage to houses occurred. With about one and a half million light timber frame houses in New Zealand, good seismic performance is essential to ensure accommodation is available to the majority of residents in the aftermath of an earthquake affecting an urban area. Damage to houses by the Christchurch earthquakes was assessed in a comprehensive randomised survey by BRANZ, reported on previously. Poor construction, such as unreinforced and poorly built foundation walls, lightly reinforced concrete block walls and poor connections was observed to result in increased levels of damage. Poor layouts such as houses with dominant openings on one side, foundations that were higher or more flexible on one side than the other and eccentricities common on h

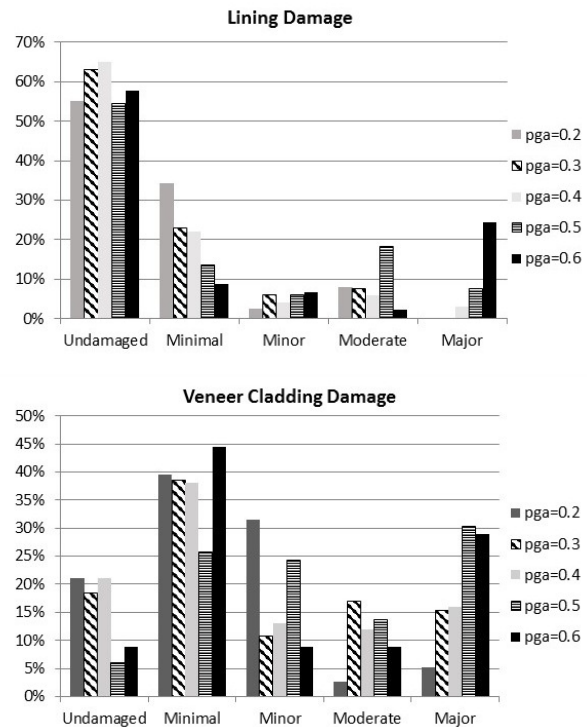
Figure 1. Lining (a) and veneer (b) damage as a function of peak ground acceleration.

respectively. The expected result is that damage would generally increase with increased peak ground acceleration for both linings and claddings. This expectation is met, which gives confidence in the accuracy of the survey, but there are some anomalies. There are a slightly lower proportion of houses subjected to a pga of 0.2 and 0.3 in the undamaged category, than those subjected to a pga of 0.4, and more in this category from pga of 0.6 than a pga of 0.5. There is obviously some variation due to statistical variation, but an obvious reason for this discrepancy is the effect of liquefaction on damage to houses on sites that experienced lower pga's.

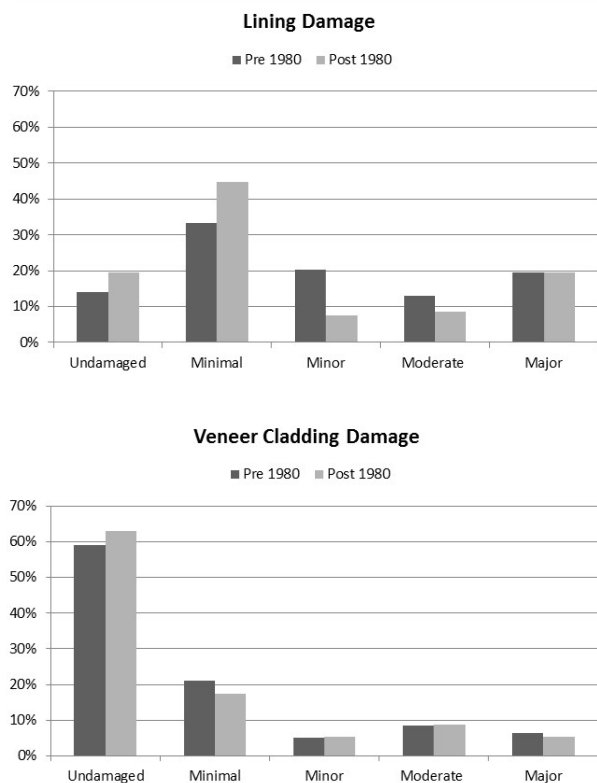
Figure 2. Cladding (a) and veneer (b) damage as a function of house age.

Although older and newer houses had a similar proportion in the “major” category for lining damage, overall the older houses performed slightly worse, with more in the minor and moderate category. There were about the same or higher proportion of houses surveyed in every category except “undamaged” for veneer damage. Pre-1980s houses had slightly less openings, but more importantly the location of openings around the houses, as measured by the relative proportions of windows on each side is more even. Hence it can be inferred that the improvement in bracing performance that occurred with the introduction of NZS 3604 has been compensated for in a large part by a trend to having dominant openings on one or two adjacent sides of a house and to a lesser extent by an increase in the overall amount of openings. Furthermore without the improvement in lateral load resistance from designing to NZS 3604, it is likely the design trend to more, and less symmetrical layouts of, external openings would have resulted in much poorer performance.

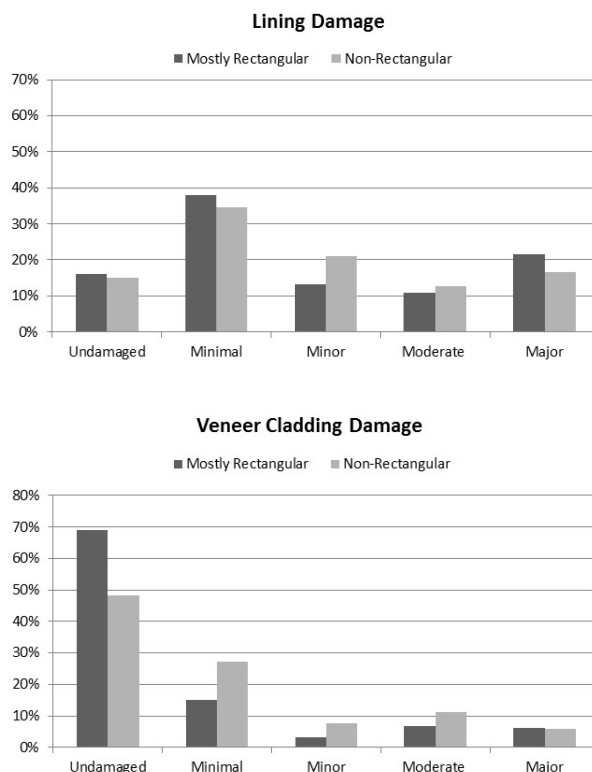
Most houses (58%) in the sample were mostly rectangular, and non-rectangular houses had more damage overall, to both claddings and linings (Figure 3).

Mostly rectangular is defined as houses that are rectangular or square or with a slight deviation from rectangular, for example a small extension of a room a few metres outside the otherwise rectangular plan. Mostly rectangular houses are more likely to be in the undamaged or minimal categories for lining damage. Close to 70% of rectangular houses had no veneer

Figure 3. Lining (a) and veneer (b) damage as a function of plan shape.

damage compared to less than 50% of non-rectangular houses. This discrepancy between veneers and linings may be because houses are planned so that re-entrant internal corners are not common as internal walls are located at the junctions of different wings, and any damage is likely to be confined to the re-entrant corner joint anyway. On the other hand with veneer claddings, there is likely to be significant differential movement between two planes of cladding meeting at a re-entrant corner with confinement by the other plane of cladding and the wall framing limiting differential movement. Therefore the cladding can only crack, displace or fall off and this damage can propagate along the length of the wall.

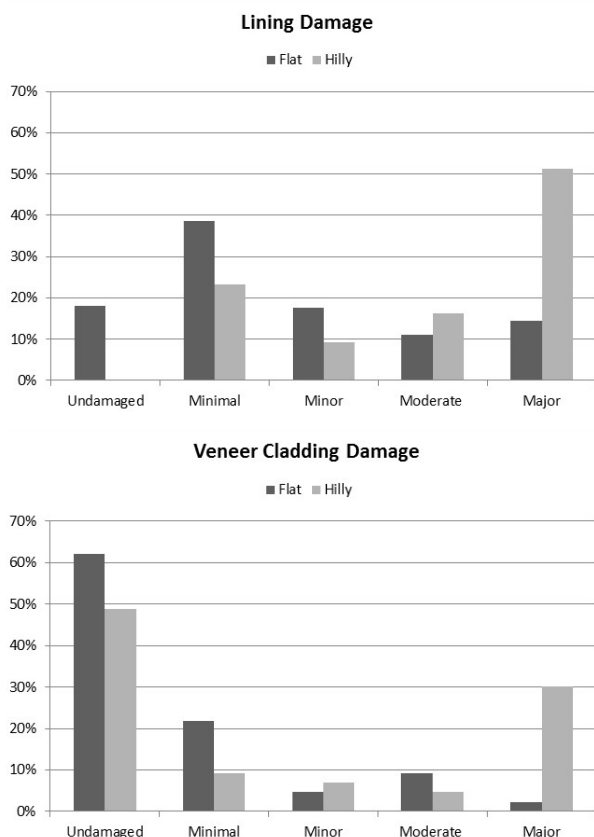
The effect of topography on damage is marked. Figure 4 shows that all houses on hilly (sloping or hill top) sites had some cladding damage. Although a higher proportion of houses on the flat (271 out of a total of 314 house surveyed) were in the minimal and minor categories, over 50% of houses on hilly sites had major damage to linings. The same trend although less marked is apparent for veneer damage, with over 30% of the houses on hilly sites having major damage to veneer claddings. This finding is complicated by the fact that the level of shaking was higher in hill suburbs. The results have been separated for flat and hilly sites compared with pga's in Figure 5 for lining damage and Figure 6 for veneer claddings to ascertain whether this result is due to the level of shaking or a combination of both.

Figure 4. Lining (a) and veneer (b) damage as a function of topography.

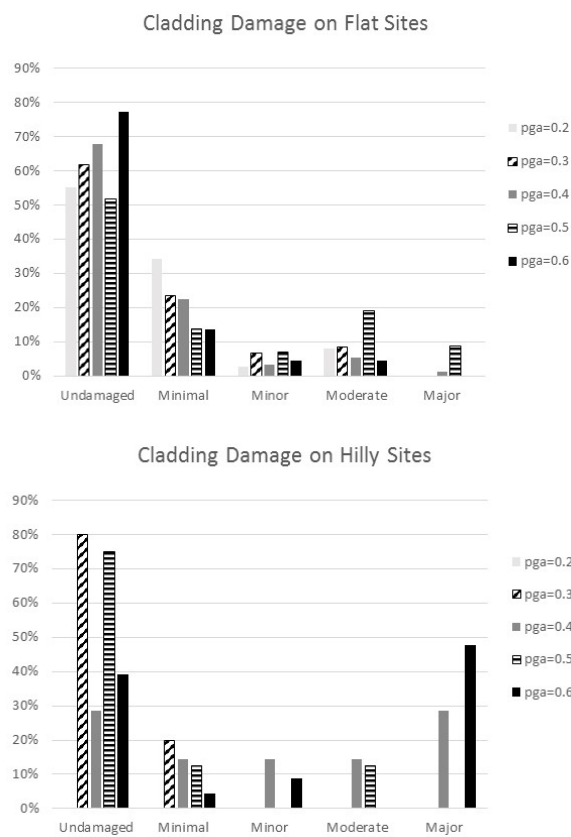
Figure 6. Veneer cladding damage as a function of pga for flat and hilly sites.

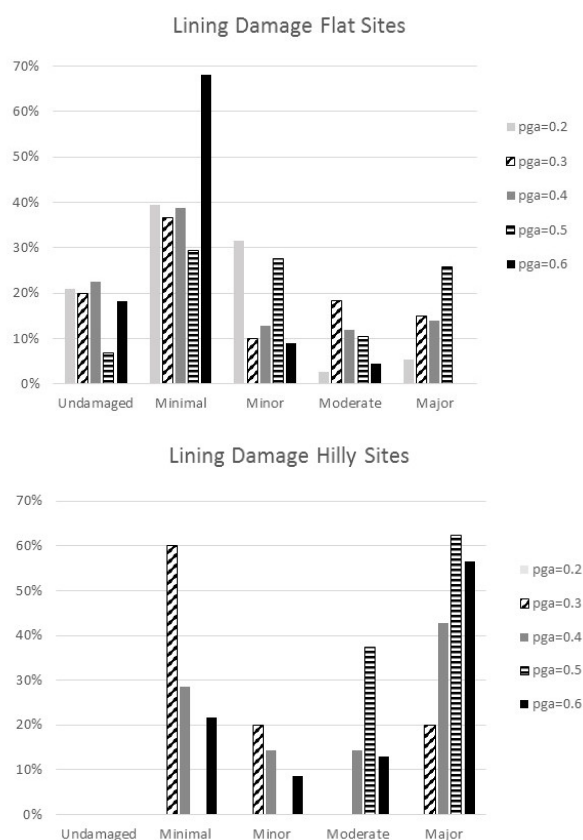
Figure 5. Lining damage as a function of pga for flat and hilly sites.

It is difficult to draw general conclusions from the middle of the range of lining damage, but at the extremes findings are more obvious. No houses on hilly sites had linings that were undamaged, regardless of the pga, but on flat sites about 17% were undamaged. In the major category there are a much higher proportion of houses in this category on hilly sites, regardless of pga. For cladding damage with a smaller sample size for both hilly and flat sites, there is more scatter in the data, but there appears to be some evidence of a trend of more damage in hilly sites regardless of pga. The increased level of damage on hilly sites regardless of pga is even more significant when the increase levels of damage on some flat sites, due to liquefaction and lateral spreading, is considered.

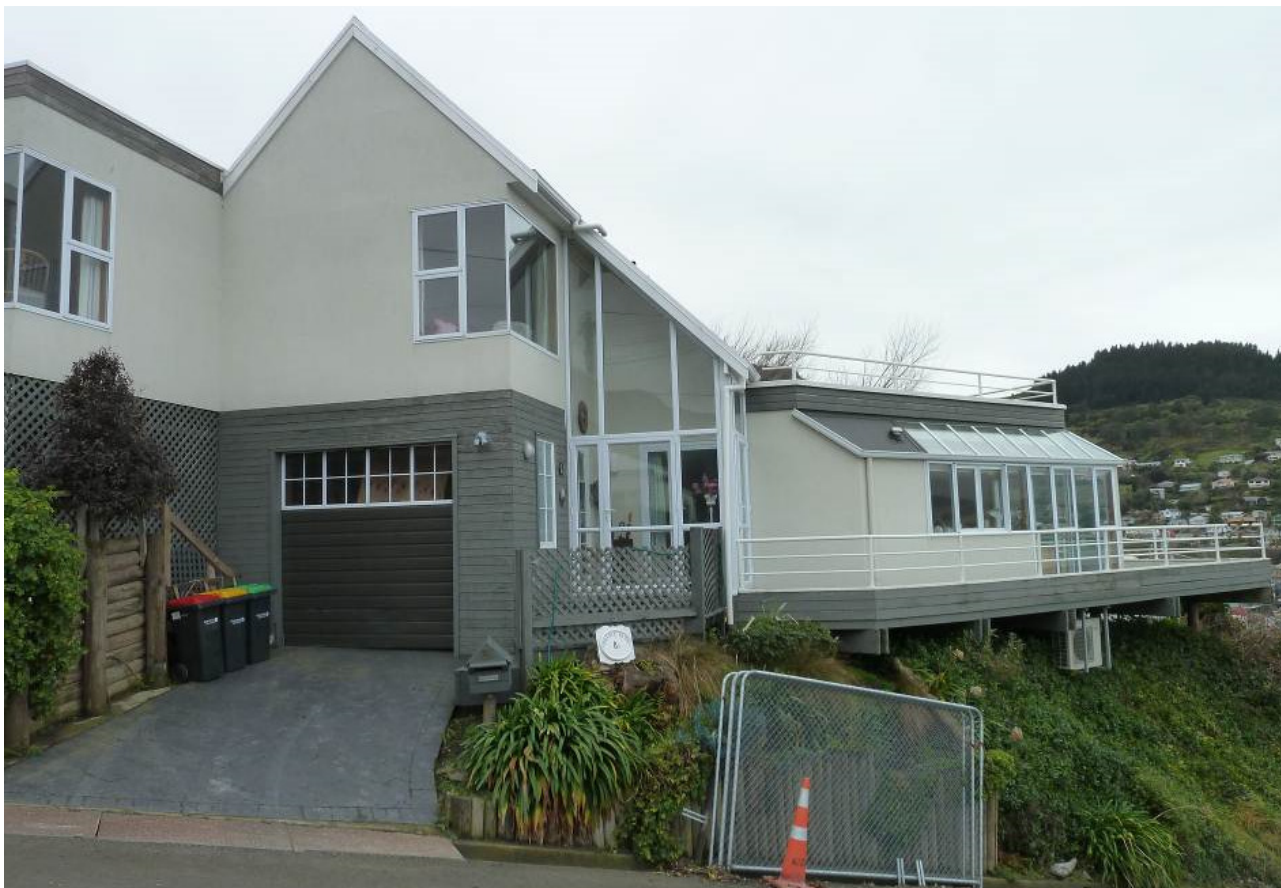
Figure 7. House on sloping site with horizontal and vertical irregularities and differing foundation types.

Another major area of work yet to be completed is the effect of openings on damage, both the percentage of wall openings in a house and their distribution around the walls. Of particular interest is house with dominant openings on one side, or two adjacent sides which could result in significant torsional problems. This analysis is complicated by houses with dominant openings on one side, facing a view, frequently being on sloping sites and also have higher foundations on the side with large openings or even different foundation types on the higher side. They may also have horizontal as well as vertical irregularities, a good example being the house in Lyttelton shown in Figure 7, which is partly on cantilevered timber beams at the front, but built into the slope on a concrete slab at the back and has vertical and horizontal irregularities.
