PROTOTYPE TESTING PROCEDURE FOR FLANGE HUNG POTIUS PANEL

Gavin Robertson

POTIUS Building Systems Ltd

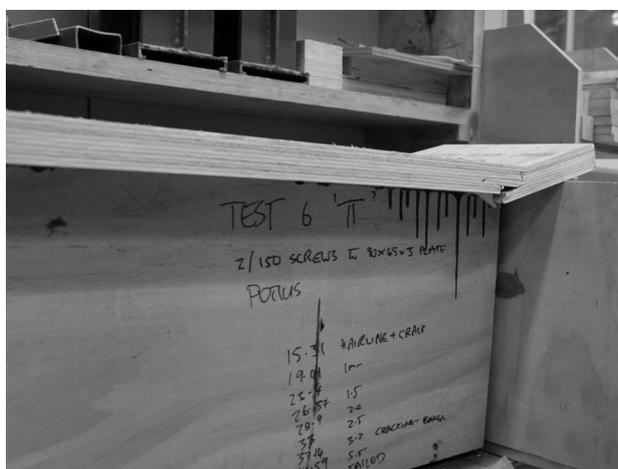
Photo 2. Unit failure

All ten units failed by the same mechanism; flexural failure of the flange at or around the screw fasteners (refer Photo 2).
