EVALUATION OF SCREWS USED IN LAMINATED VENEER LUMBER ROCKING CONNECTIONS

D. M. Carradine, M. P. Newcombe and A. H. Buchanan

Dept. of Civil and Natural Resources Engineering, University of Canterbury, Private Bag 4800, Christchurch 8140, New Zealand.

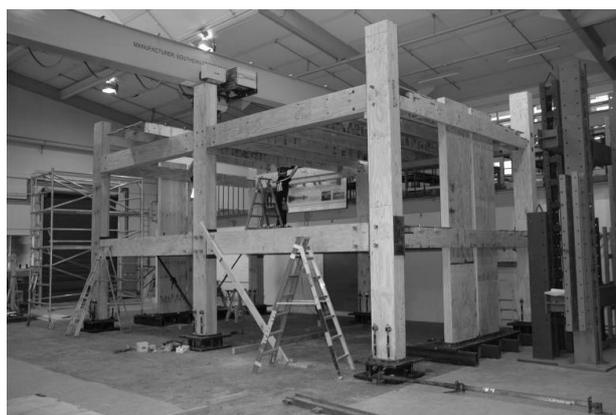
Figure 1. 2/3 Scale post-tensioned test structure at the University of Canterbury.

Experimental and analytical research on post-tensioned LVL buildings in New Zealand has focused primarily on building components including beam-column joints, and timber-concrete floor systems (Iqbal *et al.*, 2008, Yeoh *et al.*, 2008 and Yeoh *et al.*, 2011). A 2/3 scale two-storey structure using this technology was designed, fabricated by regional glue laminators and erected at the University of Canterbury as shown in Figure 1. This building was tested to assess the structural integrity of the system when subjected to biaxial pseudo-static lateral loading. To accommodate the necessary movement of the structure due to lateral loads and minimise damage to the floors during rocking, innovative connections

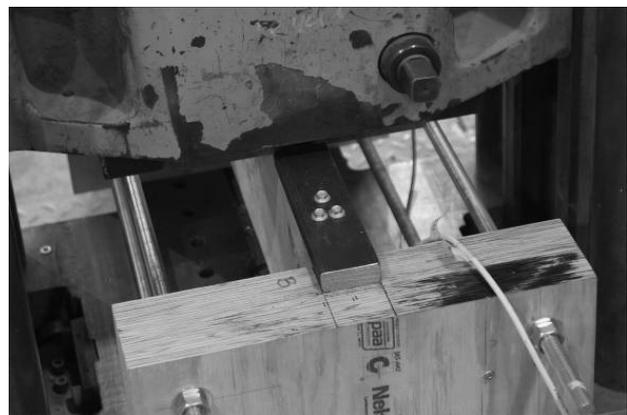
Figure 4. LVL test connection Configuration 1A.

As testing progressed on these initial four connection types, other connection possibilities became apparent and were tested also. Configuration 2 from Table 1 was tested using 6 mm diameter high tensile strength threaded rods and a 6 mm thick steel plate beneath the joist instead of relying on the withdrawal or tensile capacity of the screws but this was not included in the results as the capacity was based on threaded rod capacity. Additionally it was observed that the first screw in the row of three used for Configuration 1 was the screw taking most of the load, therefore Configuration 1A reconfigured the three screws so that the first row contained two screws rather than one as shown in Figure 4 and was only tested using pre-drilled holes.

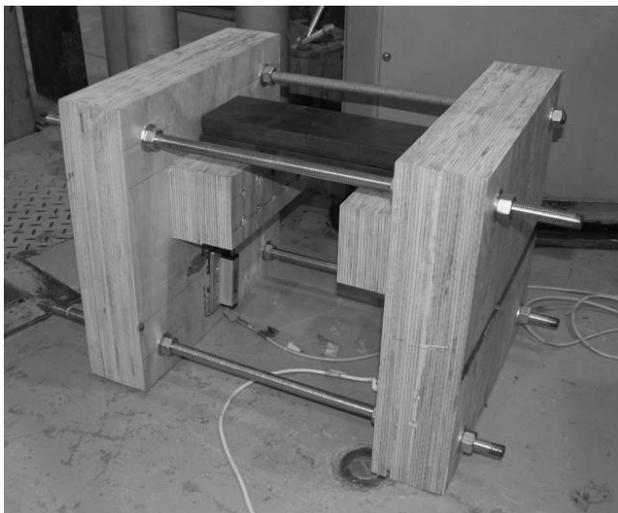
Figure 7. Corbel testing specimen for Configuration 1C.

simultaneously. Additional tests were performed with the corbels attached parallel to the glue lines of the columns, also shown in Figure 6. ASTM Standard D 7147 – 05 (ASTM, 2008a) was used as a guideline for test procedures. Loads were applied to corbels monotonically via steel plates. Based on the time to failure, the loading rate was approximately 10 kN per minute. Displacement measurements were obtained on both of the corbels relative to the column members. A typical test specimen of Configuration 1C is shown in Figure 7.
