# SEISMIC RETROFIT OF HISTORIC TIMBER STRUCTURES: UNCERTAINTIES AND ADAPTION ON SITE

M. E. Davies, G. W. Alley & A. G. Cattanach,  
Dunning Thornton Consultants Ltd, Wellington.

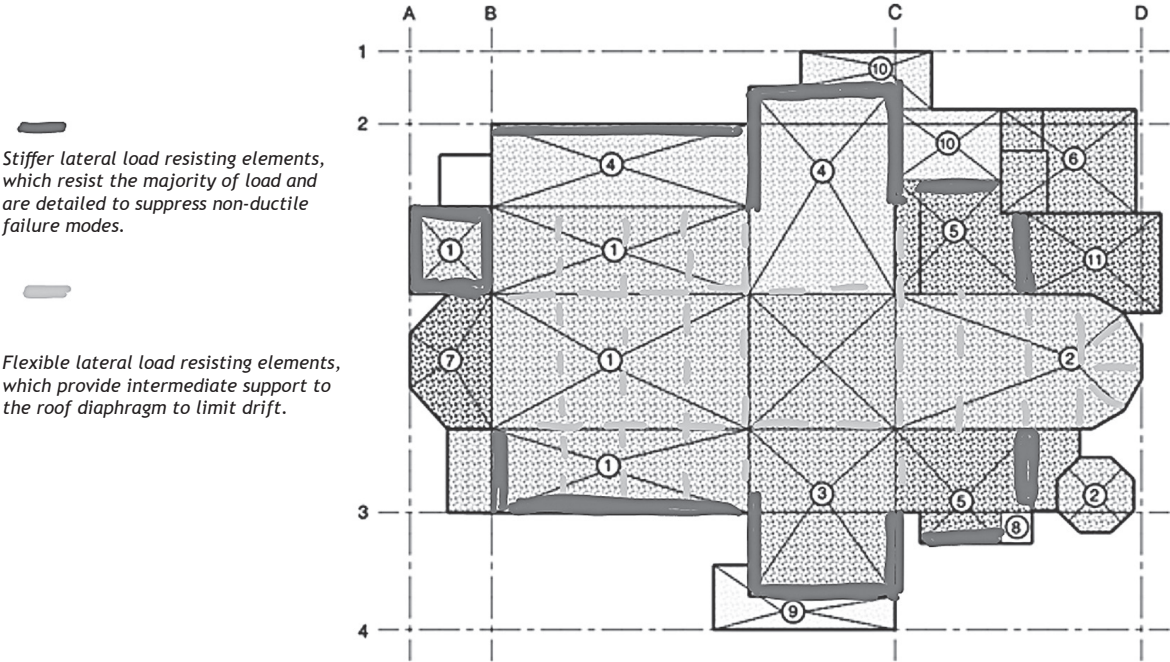
Figure 3: Schematic of lateral load resistance mechanism

As noted in the previous section, and described in Figure 3, the building is generally very flexible in the central areas (the nave, aisles, crossing, and apse). The walls in the north and south transepts and bell tower had historically been retrofit with diagonal timber bracing to reduce sway in the wind. This meant there were parts of the building with higher stiffness, excepting that the connections of the diagonal bracing typically had negligible tension capacity.

The seismic retrofit approach adopted a design intent that complemented the existing building characteristics, and included the following key works:

- Installing steel bars parallel to existing timber braces to add tension capacity to the brace connections in the transept walls and bell tower.

- Increasing the available lateral strength of the transept walls and bell towers by adding mass to the foundations to increase the overturning resistance, but still maintaining a strength hierarchy where overturning/rocking occurs before failure of non-ductile timbers/connections.
- Adding tension capacity to connections in the nave, apse and aisles to improve their lateral strength, while maintaining flexibility/resilience through detailing to a hierarchy that favoured local crushing of timber and yielding of dowel-type fixings.
- Adding a small number of horizontal tie rods to mitigate plastic dilation of timber arches.
- Creation/verification of secondary gravity load paths in the crossing to make it resilient to differential displacements from surrounding structural elements.
- Adding sub-floor bracing between existing shallow piles.

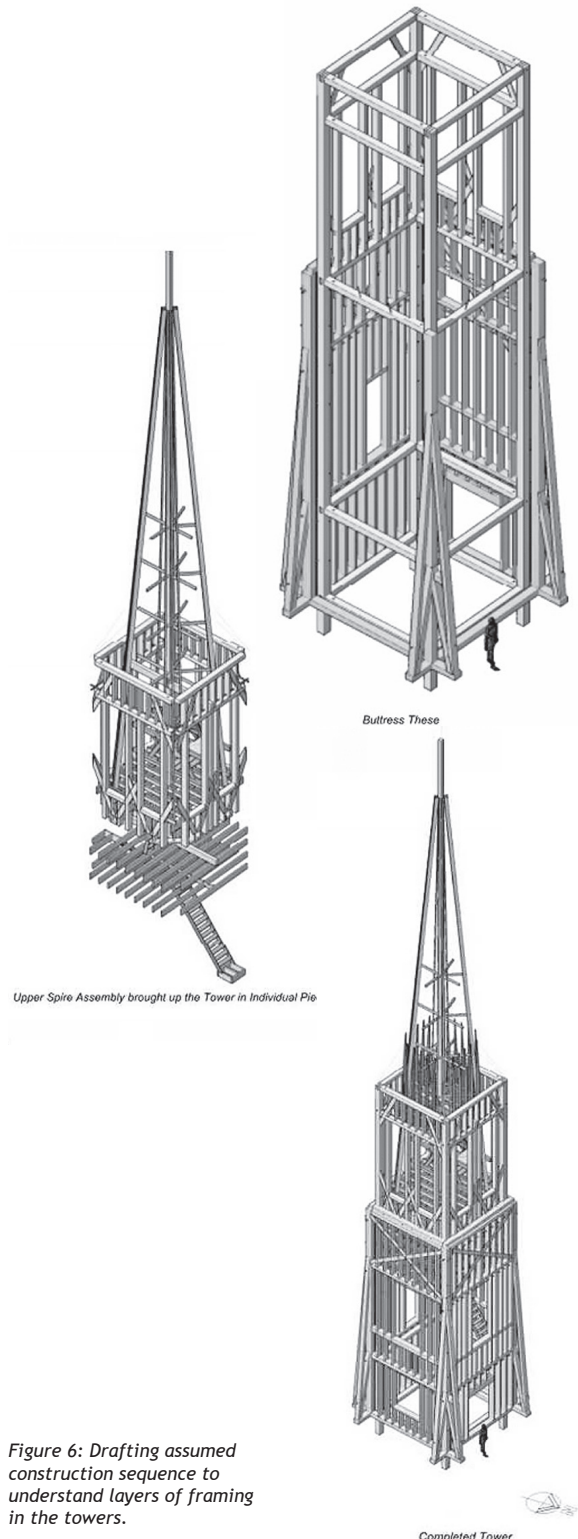
Figure 6: Drafting assumed construction sequence to understand layers of framing in the towers.

carried out a Detailed Seismic Assessment in 2012 using the (brief) timber guidance in the 2006 guidelines. Our work was based on some detailed plans prepared by Chris Cochran heritage architect, plus non-intrusive measure-up and investigations in the bell towers, roof space, and subfloor. Investigative and deductive work by Senior Draftsman Martin Williams made sense of what appeared to be double-frames in the towers

by simulating the way it could have been built and buttressed (Fig. 6) in stages, given the equipment available in the 1880's.
