# IMPLICATIONS FOR STRUCTURAL RELIABILITY AS INDICATED BY IN-SERVICE OBSERVATIONS OF TIMBER DURABILITY

G B Walford and D R Page Forest Research Institute, Rotorua, New Zealand

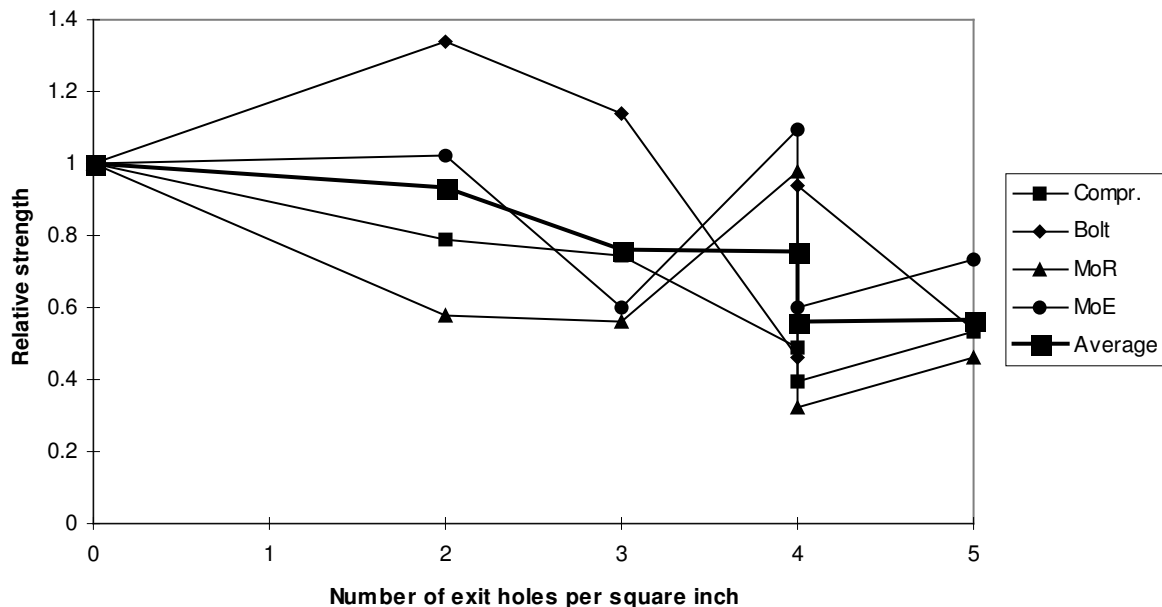
Figure 1. Effect on strength of borer attack in rimu.

A study (Walford, 1977, unpublished) on rimu used in the hangars built at Whenuapai aerodrome in 1945, revealed a relationship between loss in bending, tension, compression and bolted joint strength, modulus of elasticity, and the density of exit holes on the surface of 75x100 mm members as shown in Figure 1. From this it can be deduced that if conditions favour borer infestation then a loss of strength of up to 50% can be expected in 30 years. Another study (Gaunt & McNab, 1995, unpublished) showed losses in compression strength of 12% in radiata and 17% in rimu that had been in a structure for about 40 years. If these data are combined with information about the likelihood of attack, the particular species, temperature and moisture conditions, then it should be possible to estimate the risk of structural failure from this cause. The risk can be eliminated entirely by treating the timber with insecticidal preservatives and the cost of doing this can be weighed against the product of the probability of failure and the cost of failure.

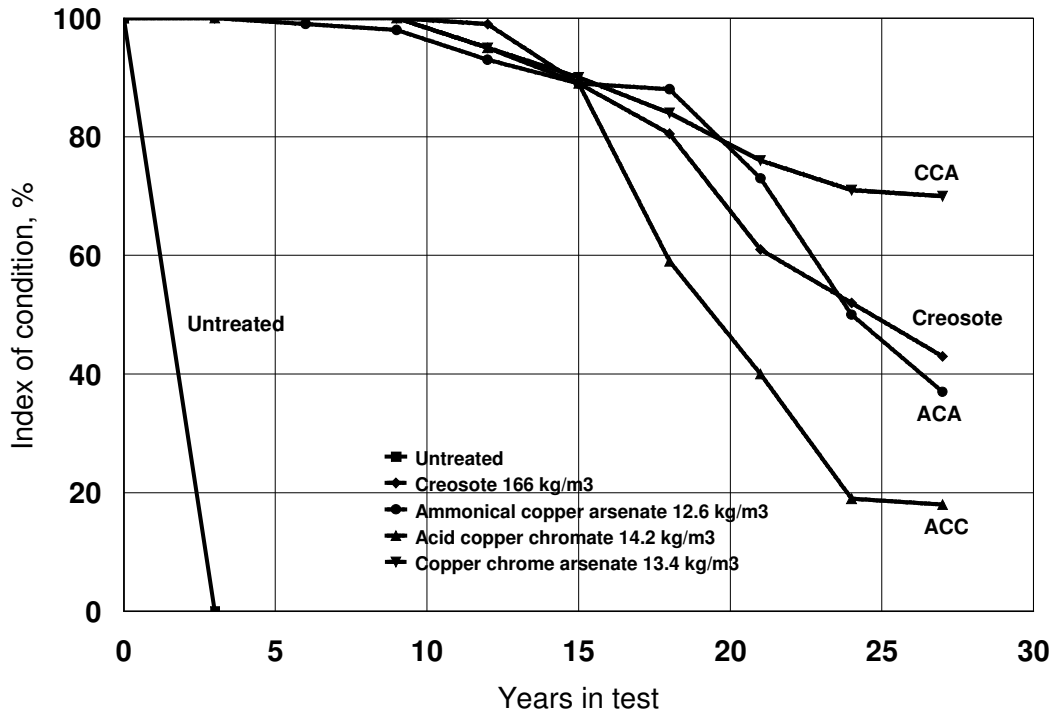
**Figure 2.** Performance of some preservatives in 20x20 mm radiata pine stakes in ground contact.

The condition index is calculated from the estimated percentage of sound cross section remaining over a large sample of stakes. It is seen that untreated timber completely rots through in three years, i.e. to a depth of 10 mm. Copper chrome arsenate (CCA) treated stakes have rotted to leave 70% of the cross section intact after 27 years, i.e. the depth of decay is 15% of 20 mm or 3 mm after 27 years. In a stake of 20x20 mm cross section this means a residual section modulus of  $100 \times (0.7)^3 = 34\%$ . Extrapolating this to treated poles of 300 mm diameter, after 27 years the residual diameter would be 294 mm. Thus the section modulus would reduce to  $100 \times (294/300)^3 = 94\%$  of the original. Figure 3 bears this out, comparing 30x30 mm stakes with 150 mm diameter posts. Rates of decay are similar but because of the larger dimensions of the posts, the percentage cross sectional loss is less. Thus estimates of the rate of strength loss due to decay can be made and explains why a service life in excess of 50 years is ascribed to treated radiata building poles.

Typical data (NZFOA, 1992) from tests of preservative treated timber in ground contact is given in Figure 2. The stakes are 20x20 mm in cross section and are pushed into soil to a depth of 200 mm. They are periodically inspected and a condition index calculated.

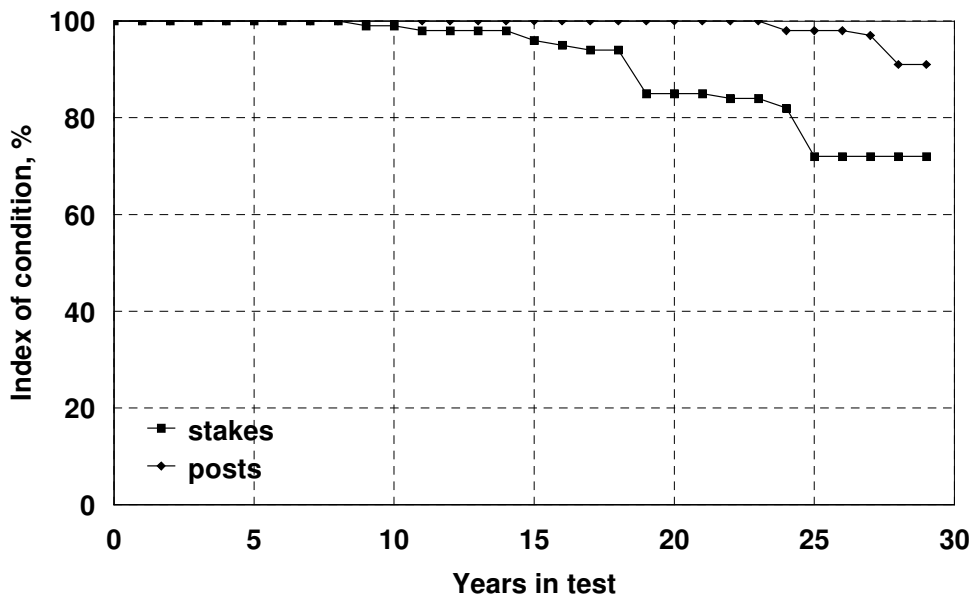
**Figure 3.** Rates of decay of 30x30 mm stakes and 150 mm diameter posts treated to H4 hazard class with CCA
