# REPAIR AND REINSTATEMENT OF DOUGLAS-FIR CLT HOLD-DOWN CONNECTIONS USING MIXED ANGLE SELF TAPPING SCREWS

T.D.W. Wright, M. Li, H. Lim  
University of Canterbury, Christchurch

*This paper was originally published for NZSEE 2022.*

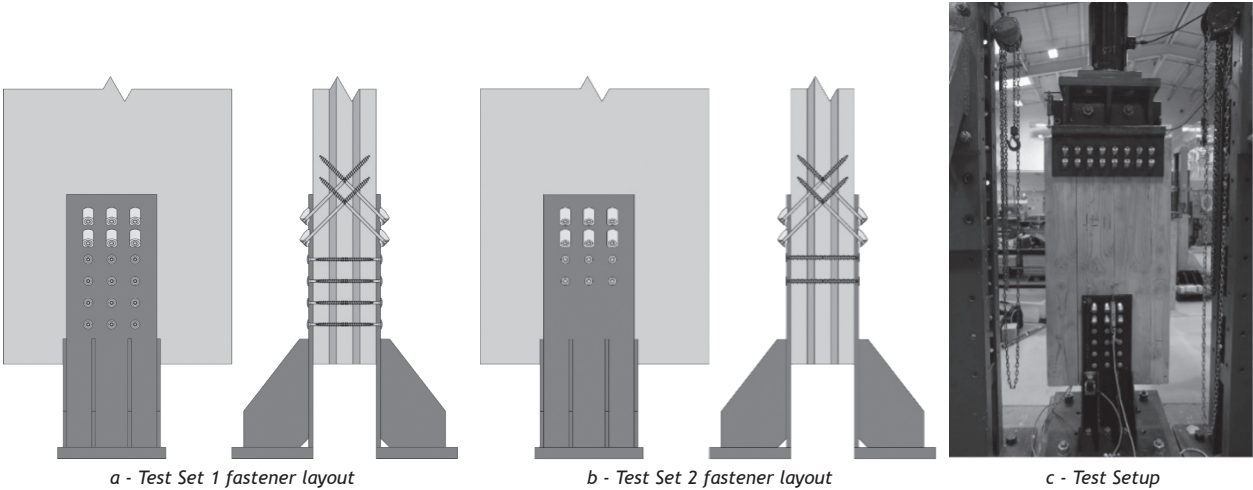
Figure 1 - Fastener layouts and test setup

Table 1 lists the test matrix including the size and amount of the screws, number of replicates, and loading types (monotonic and cyclic). A total of 16 tests were undertaken with two different mixed angle screw arrangements. All tests utilised mixed angle screw hold-down connections as described by Wright et al. (Wright et al., 2021). Test Set 1 used 12 SPAX  $\phi 12 \times 260$  mm partially threaded (PT) screws installed on a 45 degree inclined angle, and 24  $\phi 10 \times 180$  mm PT screws installed on a 90 degree angle to the grain. Similarly Test Set 2 used 12  $\phi 12$  mm by 260 mm inclined screws, but for 90 degree screws used 12  $\phi 12$  mm by 180 mm screws instead. These screw layouts are shown in Figure 1a and Figure 1b, respectively.

Testing was conducted using a 1000 kN hydraulic actuator in conjunction with a steel reaction frame. Steel hold-down brackets were used either side of a 5-ply 175 mm thick Douglas-fir CLT panel with a 45/20/45/20/45 layup, as shown in Figure 1. All screws were supplied by SPAX Pacific and inclined angle washers by Rothoblaas were used for inclined screw installations. A loading rate of approximately 0.2 mm/s was used for both monotonic and cyclic tests. The cyclic loading protocol followed the ISO16670 test standard and was based on the monotonic tests (International Organization for Standardization, 2003)

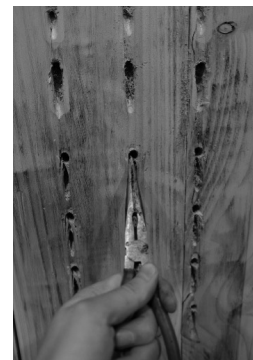
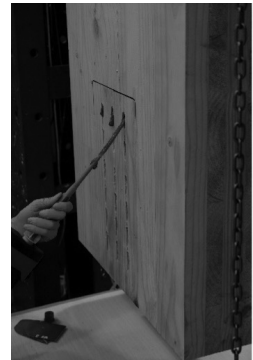
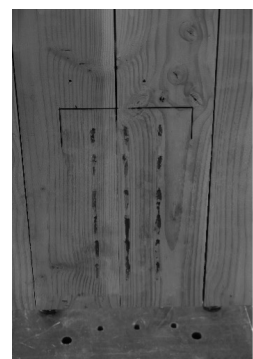
Figure 2 - Repair Process

The first step is to repair the damage to timber caused by the withdrawal of inclined screws, and the lateral deformation of the 90 degree screws. This is shown in Figure 2. First the holes are cleaned of loose timber fibres. For the inclined screw holes, this is done by reaming the hole with a drill bit sized to suit an epoxy injection tube. For the 90 degree screw holes, the loose timber on the edges of the hole is removed by hand with a chisel and pliers, or by using a handheld router to trim the edges of the hole. These holes are then blown out with compressed air to remove any remaining timber fibres or dust. Epoxy is then injected into the holes making sure that the epoxy can penetrate and fill the entire hole. In this study Hilti HIT RE-500 was used, with an extension tube being used to inject epoxy into the base of the hole similar to conventional use in concrete construction. Excess epoxy was cleaned off, and once cured the area sanded to remove any remaining excess epoxy from the timber surface.

A - Damage post original test

B - Removal of loose fibres with pliers

C - Blowing out of dust

D - Injecting of epoxy

E - Epoxy post smoothing

F - Finished repair ready for new fasteners

The second step is to shift and reinstate the connection with brand new fasteners. Due to the localised damage, the connection can be shifted and fasteners reinstalled at a small offset from the original damaged holes. When repairing with epoxy it is important to install new fasteners at an offset to the repaired holes as this avoids installing fasteners into the much stiffer and stronger epoxy. In this testing, the new fasteners were installed half way between the damaged holes. i.e. half a spacing either side to epoxy. As original fasteners were spaced at 2.5d (30 mm) a shift of 15 mm was used.

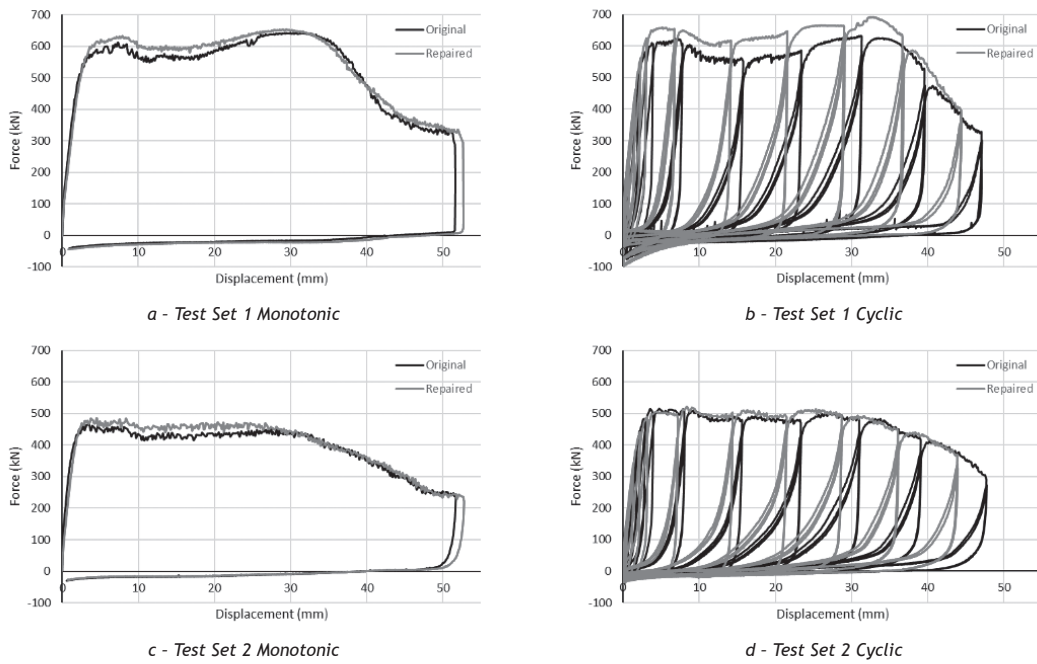
Figure 3 - Load displacement curves showing original vs repaired connections

From Figure 3a and b, it can be seen that Test Set 1 using 12 inclined fasteners and 24 10 mm diameter 90 degree fasteners has greater ultimate and yield strengths than Test Set 2. Test set 1 reaches a clear

initial peak at a displacement of approximately 5 mm, where the inclined screws reach their maximum capacity, followed by a drop as the inclined screws withdraw from the timber. The second peak at a displacement of approximately 30 mm corresponds to the 90 degree screws reaching their maximum capacity.

Test Set 2 reaches an initial peak at approximately 5 mm displacement as shown in Figure 3c and d, but in contrast to Test Set 1 has no second peak at approximately 30 mm due to the reduced number of 90 degree screws decreasing the load carrying capacity at high displacements. Covered in more detail by Wright (Wright et al., 2021), this shows how inclined to 90 degree screw ratio can be used to adjust the performance of the overall connection.

This increase in strength could be due to two factors: 1) some of the inclined fasteners may hit layers of epoxy on installation. This would lead to an increase in withdrawal strength in the inclined fasteners, and be evident on the initial peak seen in Figure 3; and 2) the epoxy may provide a local reinforcement of

Based on the curves presented in Figure 3, it was most likely that the increase was due to inclined fasteners hitting epoxy as the greatest increase in strength is at the initial peak.

Displacement capacity or ultimate displacement is shown in Figure 4c, and ductility results are shown in Figure 4d. In most tests repaired displacement capacity was still quite high, although slightly lower than the original ones. From Figure 3, it can be seen that the performance of the original or repaired curves is very similar. In this study, ultimate displacement is defined as the displacement where the load drops to 80% of the peak. Due to the slight increase in strength discussed previously, this definition of ultimate displacement is causing the repaired ultimate displacement values reported to be slightly smaller than the original even though the performance of the repaired test was very similar to the original test. Comparing the load displacement curves of all original and repaired tests, there is no significant change in performance at large displacements. Similarly, ductility is highly dependent on the yield point of the connection. In stiff but highly ductile connections such as mixed angle screws, small changes in yield displacement can result in large changes in ductility. When considering the previous discussion about variability in stiffness, the differences in ductility observed should be considered with caution.

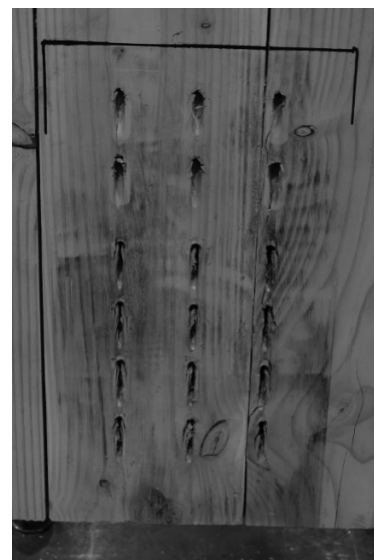
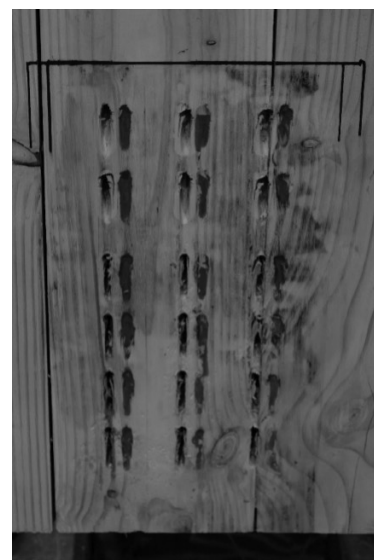
Figure 5 - Comparison of timber surface after original test and after repaired test

a - Original

b - Repaired

As previously discussed, mixed angle screw connections may have highly localised damage when detailed correctly. In all the tests presented in this paper, partially threaded screws were used to encourage a ductile withdrawal failure in the timber, rather than a brittle steel tensile failure in the screw. In all original tests, the failure mode observed for the inclined fasteners was screw withdrawal. In Test Set 1 using 10

mm 90 degree screws some screw head failures were observed in the 90 degree screws, but it was found that there was a strong correlation between incidents of over-torquing during installation and head failure on these 10 mm washer head screws. In Test Set 2, all 90 degree screws failed due to bearing in the timber. No significant changes in the damage to timber were observed between original and repaired tests, as illustrated by the original and repaired Specimen 1.2 in Figure 5. In both original and repaired tests there were instances where cracks formed along a row of fasteners, but this row shear was restrained by the internal CLT cross-layers. There was no evidence to suggest any differences in failure mode due to epoxy repair, although it should be noted that in some cases epoxy was hit when installing the screws. As previously discussed this may result in an increase in withdrawal strength, but due to the partially threaded inclined and 90 degree screws, this increase in screw strength did not result in screw tensile failure.
