END-OF-LIFE WOOD QUALITY OF MOORING POLES.

ABSTRACT: The wood quality of an out-of-service timber mooring pole (wood species *Dicorynia guianensis*) has been assessed after 40 years having been in service. The resistance level of wood species against fungi determines predominantly the propagation of degradation of timber in hydraulic structures in the critical area around the water-line. Several tests have been performed in order to determine the residual strength and the natural durability. Results of the tests showed that the natural durability of the timber was still comparable with fresh timber. Also the test results show that the mechanical properties have most probably not changed over time and are comparable with new basralocus. The results of this investigation can be used for decision making regarding possible re-use of structures in the same condition or increase the service life of same timber structure.

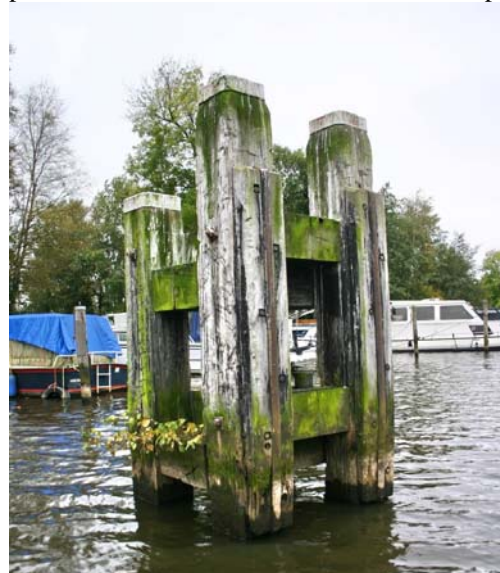
Figure 1: Mooring pole Zwartsluis/Netherlands

The mooring pole to be investigated, had been in service for 40 years, exposed to harsh conditions in Dutch waters. That pole was considered for replacement. The wood *basralocus* (*Dicorynia guianensis*) originated from Suriname is assigned to durability class 2 according to EN 350-2 [2]. The pole had a cross section of 0.32×0.32 m² and a length of 18 m. For investigation the pole had been cut into sections considering the air, water and soil zone. Visually most decayed zone was the water-air line. Furthermore the cross section of the pole had been divided in different zones of heart- and sapwood along the radial direction, because after the service period a wider spread of wood quality was expected.
